**Potable Water Pipe Condition Assessment For a High Rise
Condominium in The Pacific Northwest**

December 3, 2012

Prepared by: David M. Coles, PE, President, Coles Consultants and
Daniel R. Robles, PE Community Engineering Services, PLLC

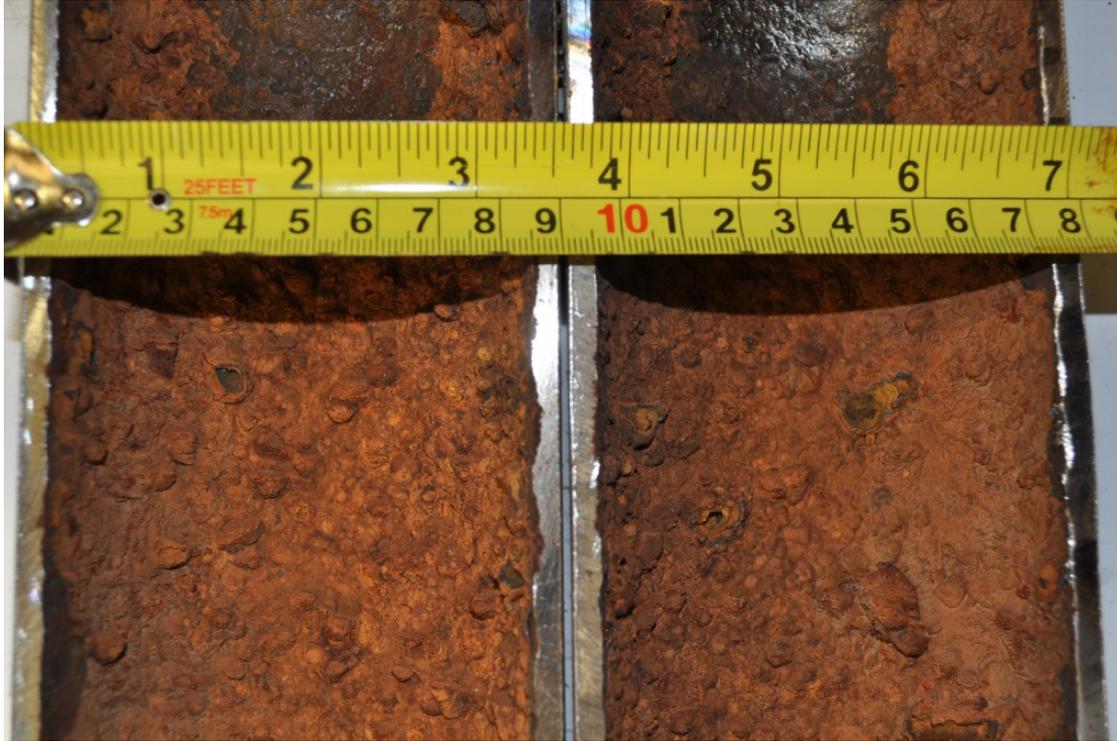
Figure 1b: This section was taken from the 3-inch cold water horizontal line in the mechanical room. The surface demonstrates heavy growth of rust nodules. Most of the larger ones fell off during the cutting process. Note: The side walls show evidence of deep pitting in the wall thickness profile.

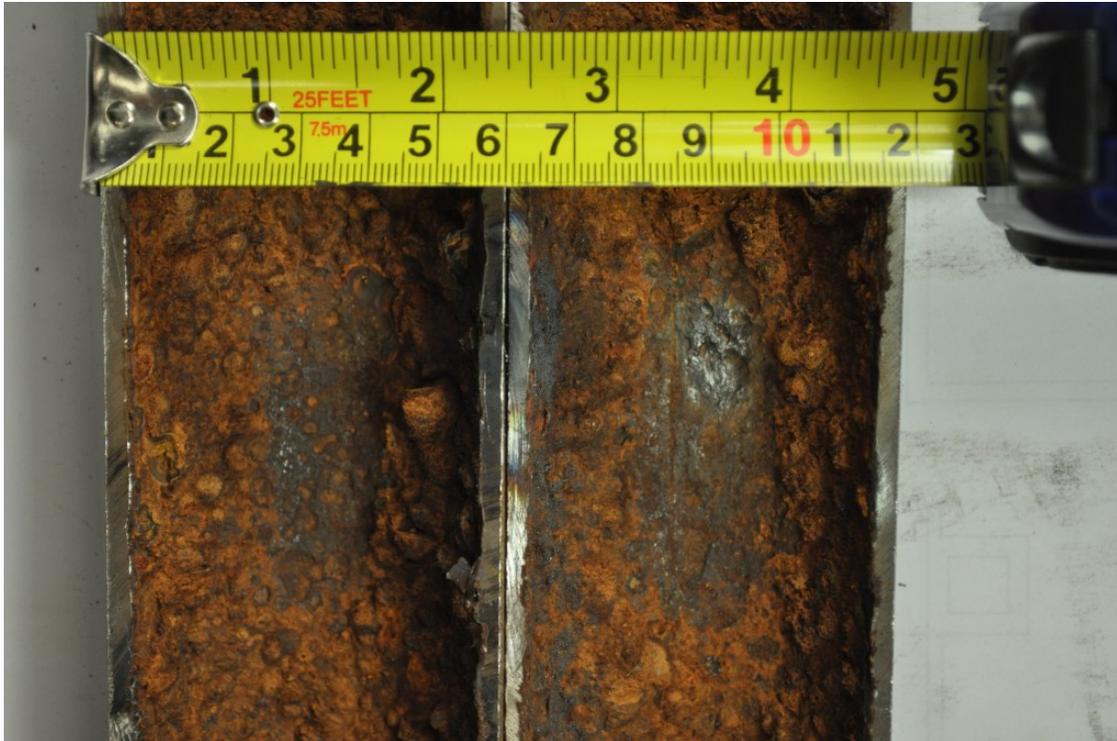
Figure 2b: This section was taken from the vertical cold water riser at the 16th floor. Nodules and rust debris dislodging from this height may sink to lower floors or pass into the water system. Remaining wall thickness is frequently less than 1/2 of the original dimension. Note: shiny areas have been cleaned for inspection.

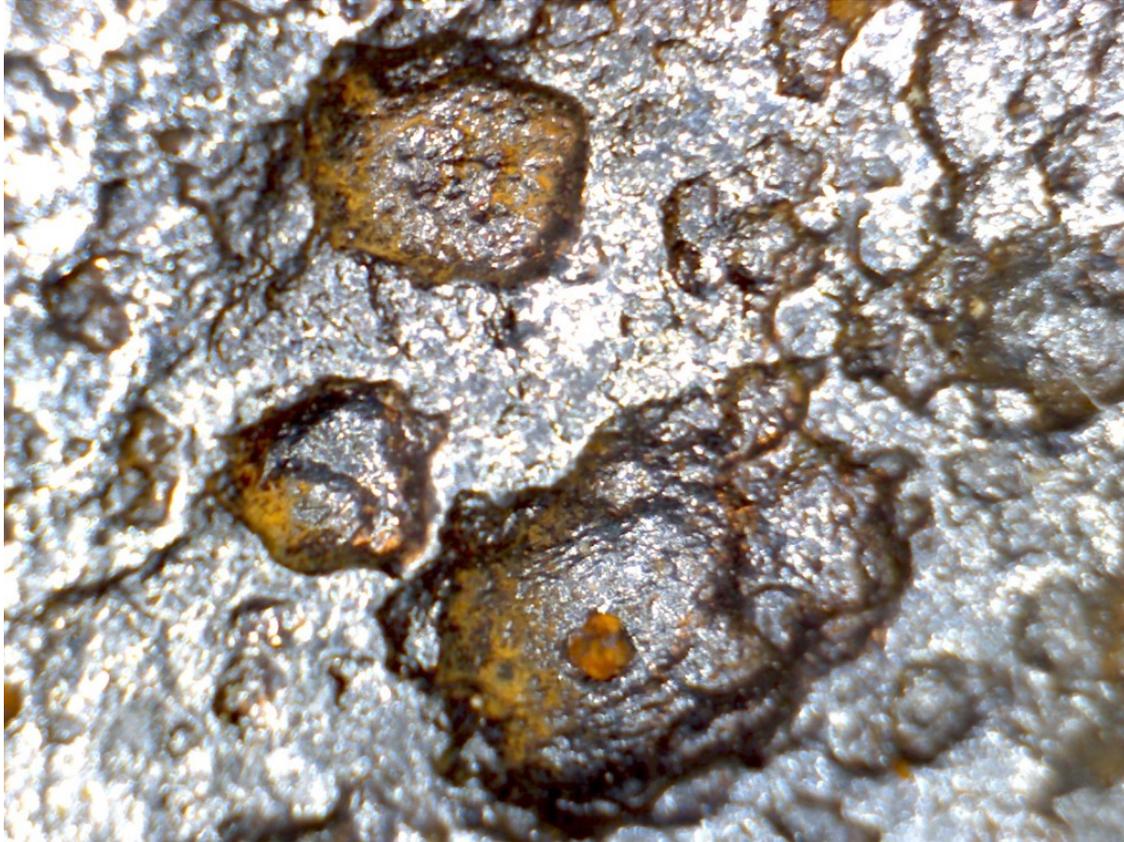
***Figure 2c:** Surface was cleaned with a pneumatic scaler and polished with a wire wheel. Resulting profile demonstrates widespread pitting. These three examples were found within a larger crater (such as seen in profile view). The diameter of the larger pit shown here is about 1/4 of an inch at widest.*

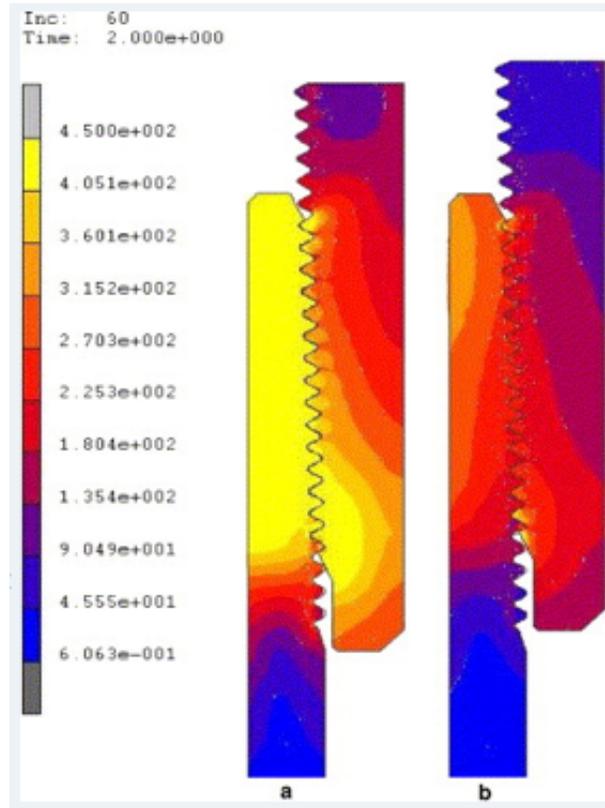
Figure 6a shows a typical (not actual) stress accumulation in pipe threads as torque is applied to the adjoining pipes (yellow is highest stress, blue is lowest). These stresses remain in the steel as stored energy - like a spring can store energy when compressed. When corrosion approaches the thread root a crack may rupture and propagate around the circumference of the pipe compromising the structural integrity.

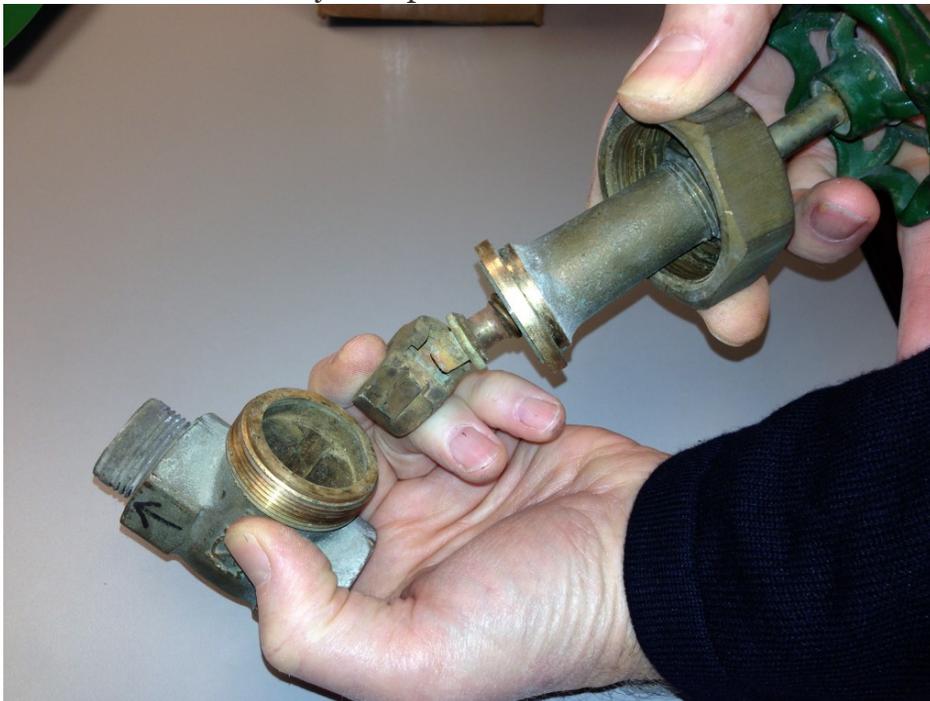
- 9a. Service was restored to building.
- 9b. Two leaks and a broken valve were discovered as a result of the extraction. One leak measured at approximately 1 drip per 5 minutes and the other measured 1 drip per 12 minutes. Root cause was determined and repair was performed two days later resulting in limited service to a single unit (by valve failure) and resulting in an additional building shut down.

Figure 7a: *This valve failed at Unit 1D. The valve was used to isolate the unit even though the whole building was shut down. This was done because the mechanical contractors wanted to open the line pressure gradually upon re-energizing the water system ahead of the repair.*
