## Space Shuttle Orbiter Drag Chute Summary

Charles H. Lowry, Consultant: Garden Grove, CA, 92844

**Abstract--This paper summarizes the development history and technical highlights of the Space Shuttle Orbiter Drag Chute Program. Data and references are given on the design, development, and testing of the system, plus several interesting operational issues and solutions.**

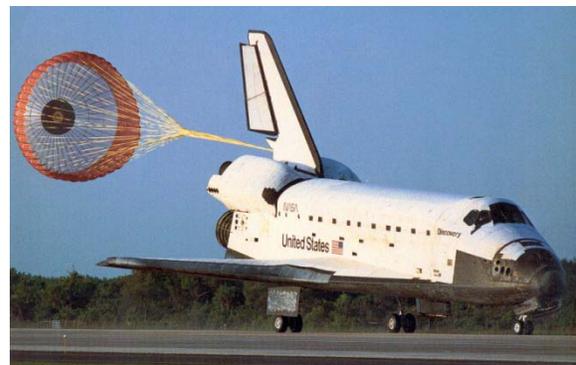
Fig. 1- Discovery Landing With ODC

division of HDT Global) was awarded the development contract in 1988. The system was designed and developed, then introduced on the May 16, 1992 maiden flight of Endeavour (STS-49), 47 launches into the program. The other Orbiters were soon retrofitted to include the system as well (Fig 1).

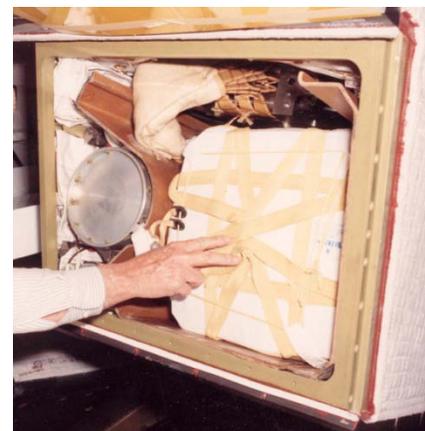
Fig 2-ODC Installation

The parachute stowage compartment is located in the tail section just below the vertical of the Orbiter, where the airstream passes on either side of the compartment and aids in the deployment of the door and pilot chute. The pilot chute mortar faces aftward as shown in Figure 2. When it fires, it shears the rivets that hold the metallic cover on and the pilot chute then proceeds to full stretch and inflates in about 1.0 sec. The force produced by the inflated pilot chute (about 4200 lb) applies tension to the 2 cut-knives, that sever the Kevlar cords holding the 130lb main chute pack in the compartment. The main chute pack is then accelerated aftward at 30 to 40 gees, so clearance with the main engine bells is assured.

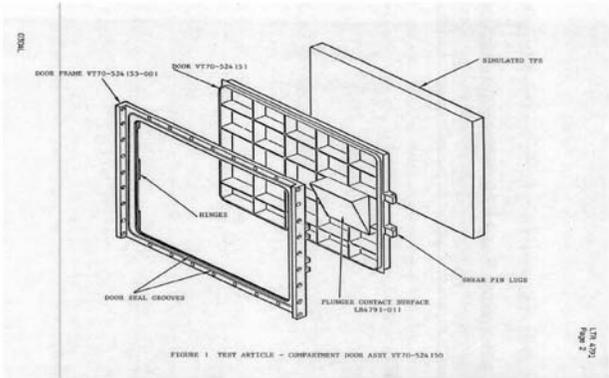
Before all that happens, the compartment door must be removed. The door has a unique jettison feature whereby it swings open on breakaway hinges by force from firing the mortar. The door is just a lightweight aluminum machining with TPS on it, with a total weight of about 12lb. Strangely, the machining ended up looking very much like the door on the Design Group repro machine (Fig 3).

Fig 3-Compartment Door

The door swings open under the force of the pilot chute pack emerging from the mortar to approximately 45 degrees at which point the hinges disengage and the door becomes a free-flying projectile. The hinge breakaway point is carefully defined to ensure the door trajectory carries it aftward (relative to the Orbiter) between the starboard OMS engine pod and the main engine bells, ensuring no contact. The door then trails the Orbiter and frisbees along behind it until it hits the runway and slides to a stop. It has been surprising to note how the flying door often defies gravity and flies formation with the Orbiter for much longer than predicted.

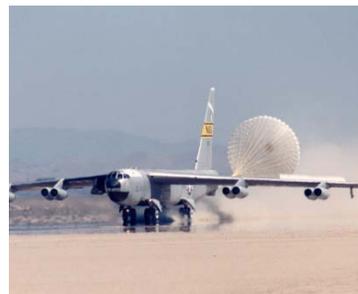
The parachute system, including the compartment and door, was flight-certified by 8 deployments behind a landing B-52 at Dryden (Fig 4)(Ref 7). Obviously we could not duplicate the Orbiter's blunt forebody, high attach point, or even the maximum landing velocity, however deployment, inflation, reefing, and door behavior were verified by those successful tests prior to installation on the Orbiter.

But the B-52 tests revealed that we were far off in our reefed canopy loads. The first 2 B-52 tests showed we were producing first stage loads that would be expected for 27% reefing, whereas we had sized the reefing line to expect 40%. This was a surprise to all involved including Sandia and Knacke, himself. Also the time from disreef to full inflation was much shorter than predicted by conventional methods. So the final reefing line length was resized and verified by continued testing.

Another notable occurrence was tearing damage on the leading edge of the Kevlar vent band of the main canopy in 3 tests. The design was changed to go back to Nylon to accommodate the concentration of load on the leading edge during inflation. This damage was showing up at approximately 65% of design limit load. Other more minor changes/improvements were incorporated during this test series, including rigging, abrasion protection, and local beefups.

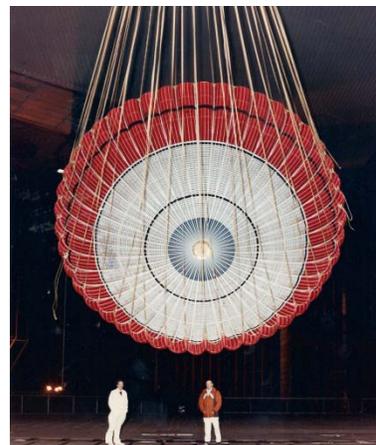
parachutes to the very large 80 by 120 ft wind tunnel at Ames and experimented with various schemes to increase the stability of the canopy (Fig 5). The most effective means was found to be increasing canopy porosity by simply incrementally cutting ribbons out of the canopy at key locations and measuring canopy oscillation. A small, lightweight sensor

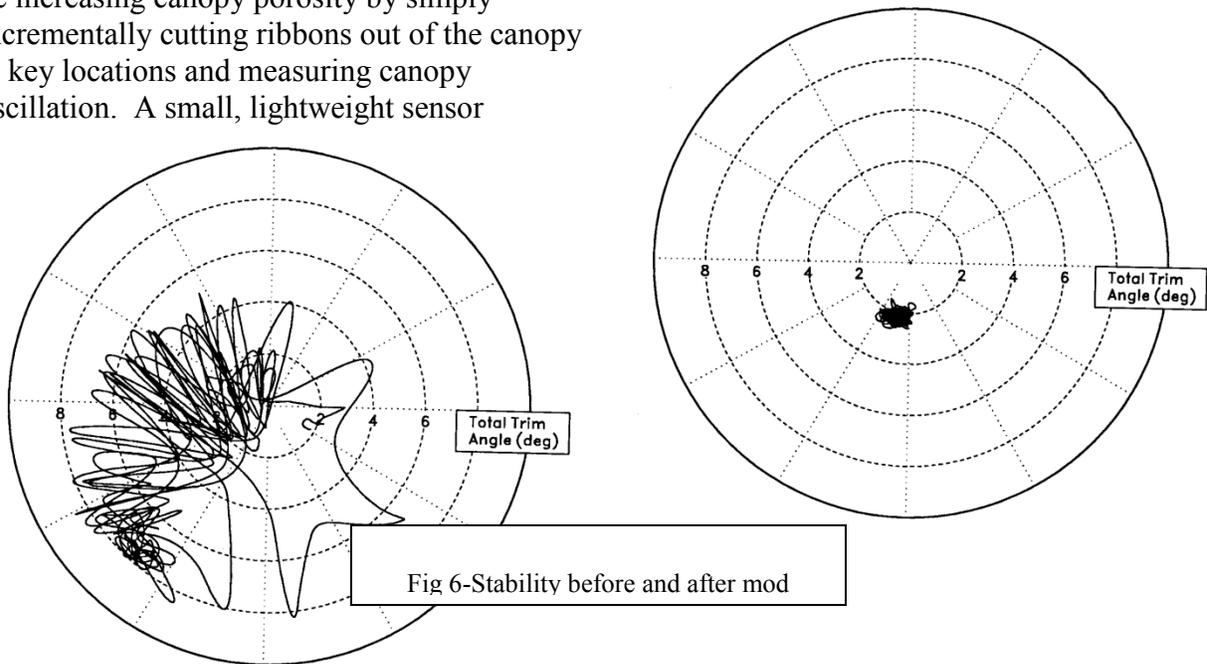
Fig 6-Stability before and after mod

was placed in the center vent area to indicate by means of tracking photography the canopy excursions (angular oscillations) at the various porosities tested. The result was that by removing 5 of the 97 concentric ribbons, increasing the total porosity from 16% to approximately 20%, stability was excellent (Fig 6) in the tunnel and loss of drag was an acceptable 7-8%. This change was incorporated and all subsequent Orbiter landings have been free of the stability issue.

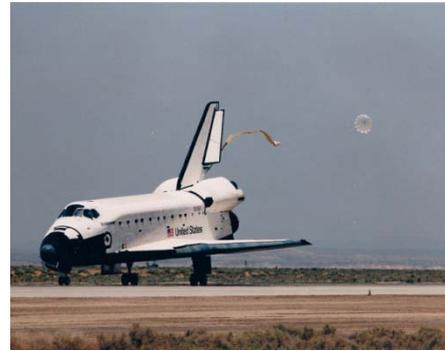
The wake field behind the landing Orbiter has a very positive up-swirl (Fig 7 & 8)(Ref 9) that results from the high-alpha wings pressing the air down against the runway, and as the wing passes over it, the air expands and causes a very measurable up component. This doesn’t adversely affect the pilot or main canopies, but the largely unkept main chute riser was being swept up and into the wake of the speedbrake. It was feared that the riser could damage or interfere with the function of the speedbrakes, so a riser sleeve was added to contain the 44 plies of webbing that comprised the riser into a smaller diameter bundle that is less affected by the local airflow. This was very effective and the concern was eliminated.

Fig 7-Riser Deflection

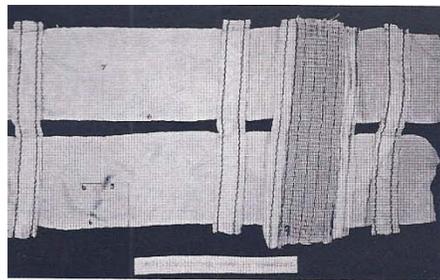
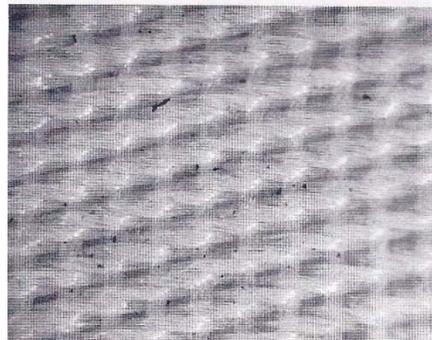
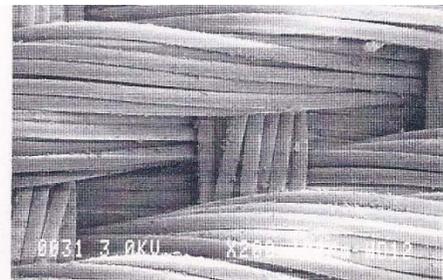
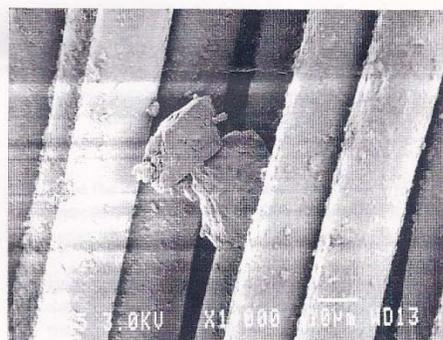
Photo 1 Control Sample

Photo 3 Control Sample (200x)

Photo 2 Control Sample (40x)

Photo 4 Control Sample (1000x)

It was desired to have a proven cleaning method that would reclaim and allow continued use of the ODC. USBI conducted tests on materials and joints from flown and dirty chutes to establish the level of degradation present, the best cleaning method, and the resulting end effects on the chutes, such as residual strength loss and shrinkage. Spectacular photos of dirty and clean textile specimens up to 2000x gave great insight as to effectiveness of various cleaning methods (Fig 9)(Ref 12). This effort should be useful to any program that worries about chute reuse after heavy dirt exposure.
